Review of May 2020 Catastrophic Tank Failure, HPP-3, Norilsk

Independent Environmental Advisory
Support to the Nor Nickel Environmental Task
Team
(ETT)

25 November 2020

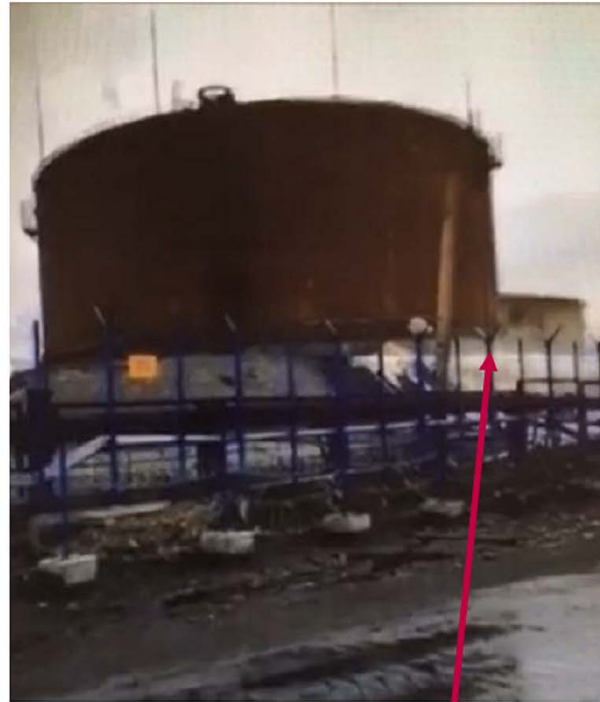
The dynamic force of the diesel release resulted in the overtopping of the bund wall

- *Check the bund capacity/ design of all tanks as it may be necessary to construct a secondary bund around these tanks, reduce the height of the bund wall between tanks or increase the overall bund capacity*
- *Undertake modelling to determine where to locate tertiary containment systems, inform emergency response planning and located spill response equipment*
- *Look to the provision of emergency response access routes and booming locations*
- *Update the spill response plan and carry out emergency response exercises*

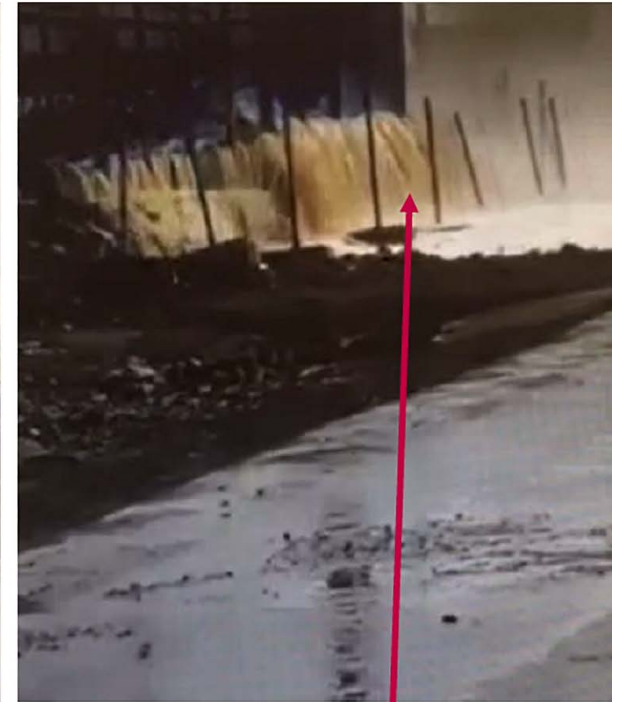
Diesel flowing through the fence and off-site

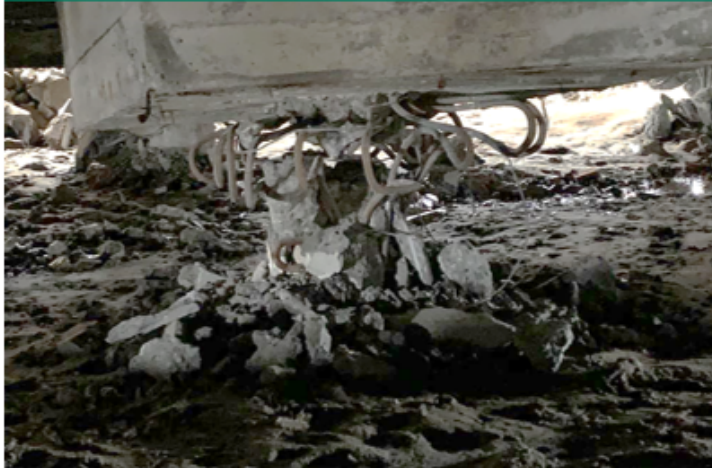
Post Incident – Pile Damage

Failure of some of the reinforced concrete piles which supported the tank

- The likely cause of the tank failure was differential subsidence of the tank base foundation. This would appear to have been a result of the failure of some of the reinforced concrete piles which supported the tank.

- This subsidence resulted in a rupture of the tank shell where the wall is welded to the base.
- Preliminary results of the regulator incident investigation reported that several of the piles were found to be shorter than the design length and not installed 800mm into the bedrock. This would mean that these piles were supported by the permafrost soil layer rather than the bedrock.

- Any warming and melting of the permafrost would reduce the adfreeze and bearing capacity of these soils relative to that of the bedrock and render such piles susceptible to potentially rapid creep settlement as the permafrost warmed under and around the tank.

- This suggests that increasing permafrost temperature, linked to reduced adfreeze and bearing capacity of soils and resultant creep settlement of the piles not installed into bedrock was the likely failure mechanism.

- *Inspect foundations of all tanks with the similar pile design as Tank No.5 to look for evidence of subsidence and confirm all piles installed as designed. Remove or reduce fuel level in “at risk” tanks*

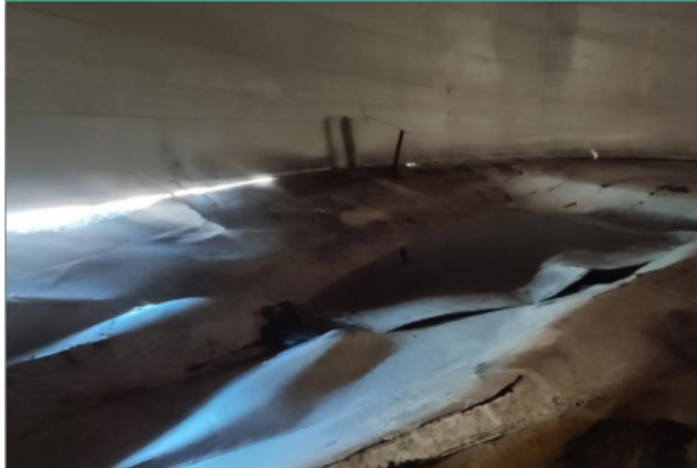
Post Incident – Collapsed Tank Floor

Interior of the tank showing a large depression caused by pile failure which in turn caused failure of the common plates dragging the annulars inwards resulting in failure where the plates met the shell

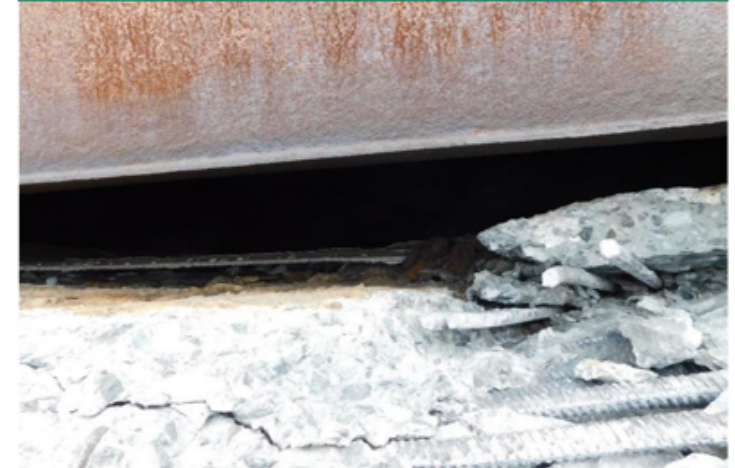
Post Incident – Tank Shell Rupture

Rupture of the tank shell where the wall is welded to the floor
