Review of May 2020 Catastrophic Tank Failure, HPP-3, Norilsk

Independent Environmental Advisory
Support to the Nor Nickel Environmental Task
Team
(ETT)

25 November 2020

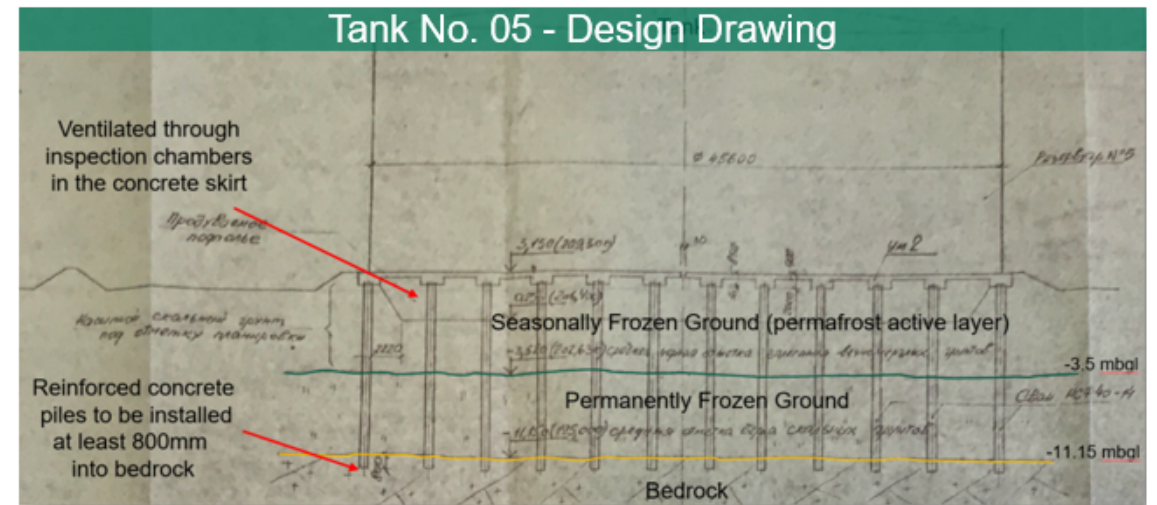
- The likely cause of the tank failure was differential subsidence of the tank base foundation. This would appear to have been a result of the failure of some of the reinforced concrete piles which supported the tank.

- This subsidence resulted in a rupture of the tank shell where the wall is welded to the base.
- Preliminary results of the regulator incident investigation reported that several of the piles were found to be shorter than the design length and not installed 800mm into the bedrock. This would mean that these piles were supported by the permafrost soil layer rather than the bedrock.

- Any warming and melting of the permafrost would reduce the adfreeze and bearing capacity of these soils relative to that of the bedrock and render such piles susceptible to potentially rapid creep settlement as the permafrost warmed under and around the tank.

- This suggests that increasing permafrost temperature, linked to reduced adfreeze and bearing capacity of soils and resultant creep settlement of the piles not installed into bedrock was the likely failure mechanism.

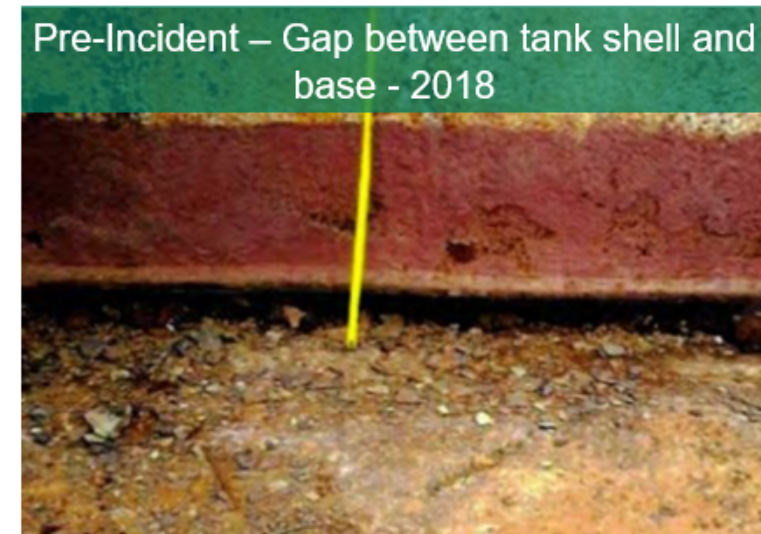
- Insufficient attention has been given to the emergency diesel tankage both in terms of its likelihood and realisation of the implications of failure.

- Consequentially the levels of management and safeguarding are below that expected from the volume of tankage present.
- There appears to have been a reliance on the tank having been considered regulatory compliant as a consequence of regulator inspections over the preceding 2 years, in part resulting from an inadequate understanding of the potential risks and management of them.

- This is highlighted by a series of missed signals and lack of specific monitoring which in combination could have been taken as warning signs of the subsidence and in hindsight avoided the failure. These were:

- Loss of verticality and 80mm gap between the foundation and the tank floor detected during the Industrial Safety Expertise in 2018 that jointly could be considered indicators of subsidence

- Lack of focus on the foundation during the tank inspection
 - Lack of permafrost monitoring (not required by the regulations due to the tank design)
- However underpinning all of this is the fact that if all piles had been installed as designed into the bedrock, this failure would not have happened.
